**Flood Control Project Maintenance  
Levee Inspections**  
**LMA District Cover Sheet**  
**Spring 2018 Levee Inspection Results**

**Sacramento Maintenance Yard East Levee Yolo Bypass**

**Levee Inspection Report By Mile - Spring 2018**

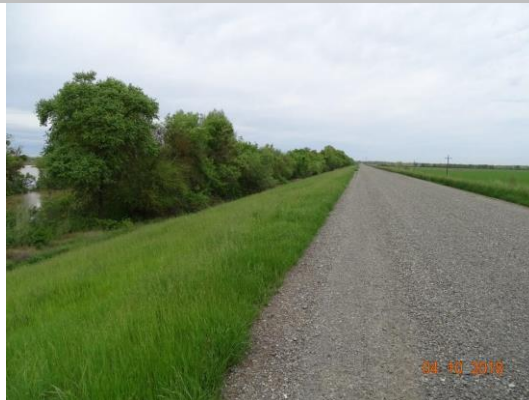
Photo 1 of 1 : SP\_2018\_ST0004\_41\_6\_20180413\_00004.jpg

LM Start	0.07	Rating **	M	Issue No.	6
LM End	2.01	Issue Type +	Ma	Location *	WS
Category	Earthen Levee			GPS Latitude/Longitude	
				Start	End
Item	Vegetation			38.764333 °	38.736278 °
				-121.635518 °	-121.633686 °
DWR ID	DWR_ST0004_01_s_2018_6				
Comment Code					
V1 : Control annual grass and weeds on the levee slopes and easements.					
Inspector Comment

View of vegetation on the waterside slope. Spring 2018.

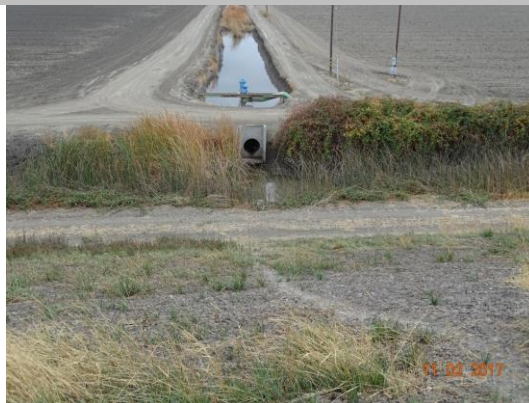
Photo 1 of 3 : SP\_2018\_ST0004\_41\_1\_20180306\_00001.jpg

LM Start	1.51	Rating **	A/W	Issue No.	1
LM End	1.51	Issue Type +	Ob	Location *	LS
Category	Earthen Levee			GPS Latitude/Longitude	
				Start	End
Item	Erosion / Bank Caving			38.743573 °	38.743573 °
				-121.634128 °	-121.634128 °
DWR ID	DWR_ST0004_01_f_2016_1				
Comment Code					
E1 : Note and monitor erosion site.					
Inspector Comment					
Erosion on a side of a ditch toward LS toe caused by water coming out of irrigation canal. Recommend monitoring.

Updated view of erosion on toe road. Fall 2017.
